## DIMENSION CHANGES IN MILLWORK DUE TO VARYING ATMOSPHERIC CONDITIONS

UNITED STATES DEPARTMENT OF AGRICULTURE
FOREST SERVICE
FOREST PRODUCTS LABORATORY
Madison, Wisconsin

## DIMENSION CHANGES IN MILLWORK DUE TO VARYING ATMOSFHERIC CONDITIONS 1

J. S. MATHEWSON, Senior Engineer

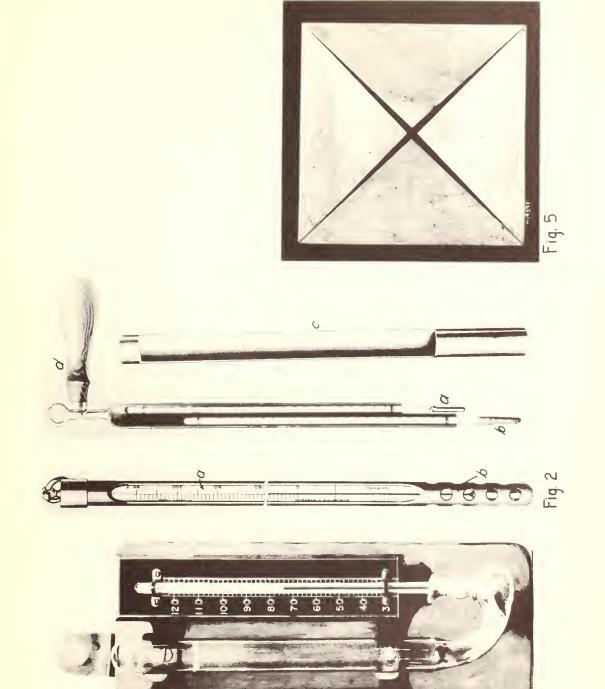
Fig.1

In Figures 1 and 2 are shown two common forms of instruments, either of which may be used for determining the relative humidity of the atmosphere. Both have similar mercurial thermometers and the bulb of one thermometer in each instrument is covered with a cloth wick kept moist. The first instrument is fanned vigorously for several minutes before the thermometers are read and the second instrument is whirled. The first is called a wet-bulb and dry-bulb hygrometer, and the second. a sling psychrometer. The readings of the pair of thermometers in either instrument, when referred to a table furnished with it, afford a means of determining the relative humidity.
